# Major Maintenance and Repair Action

## Hull 269 – Jade

Maintenance or Repair Action: Repair Ignition System Number: 002

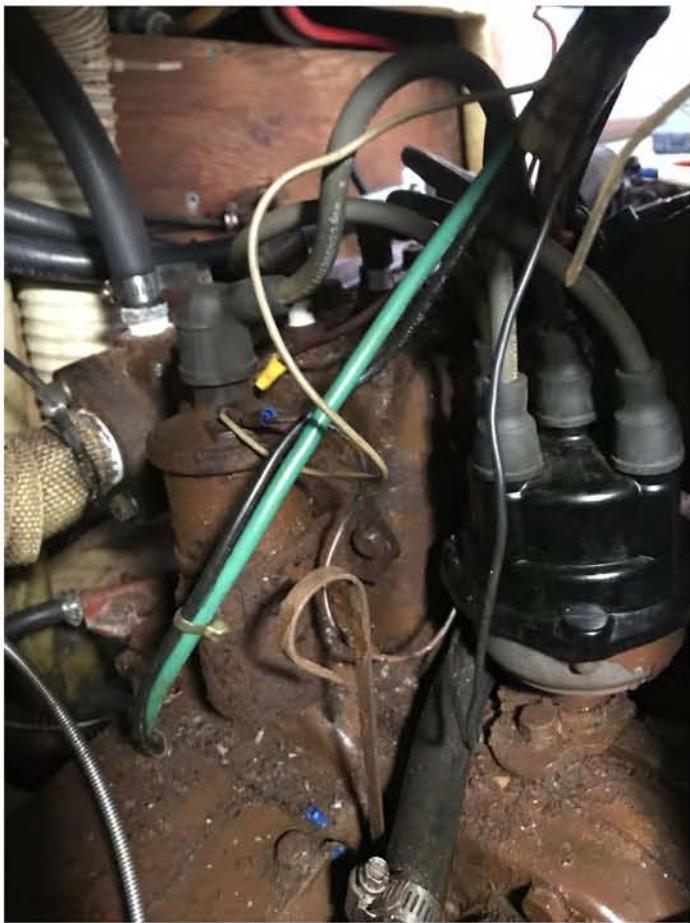
Distributor/Ignition System as found

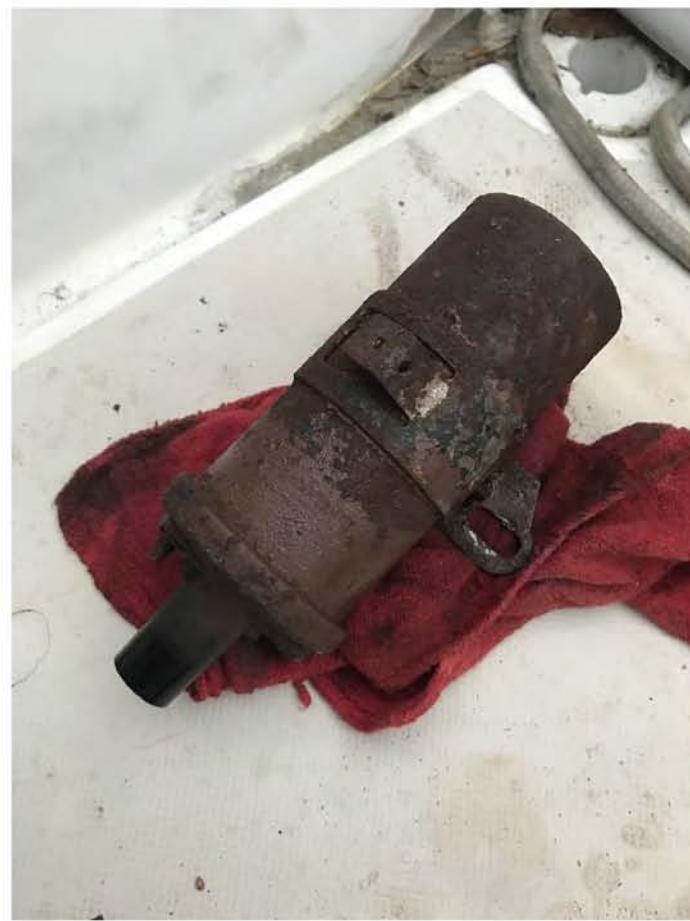
Old Ignition Coil removed

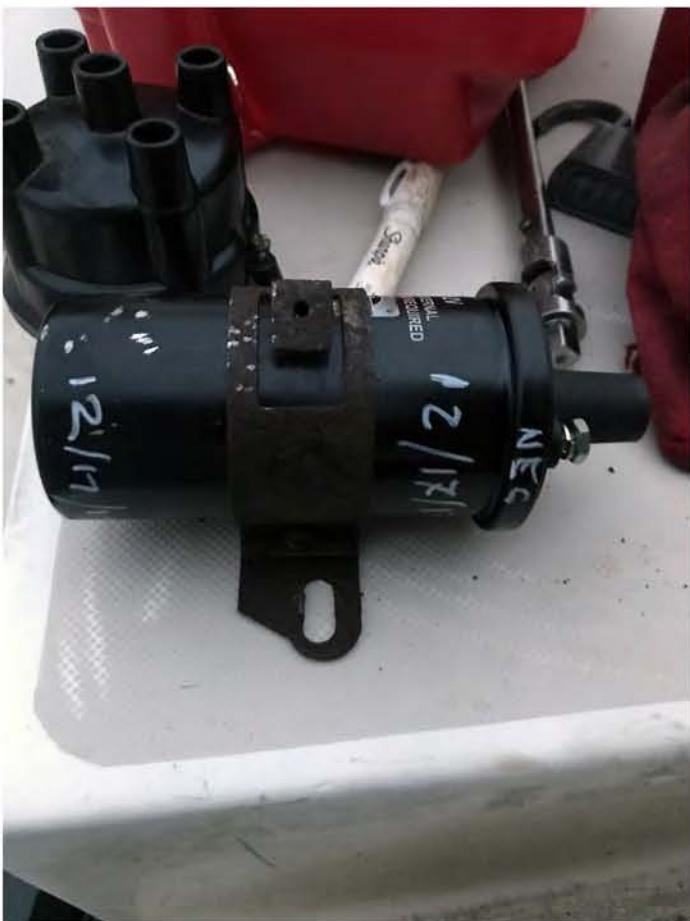
New Ignition Coil and Distributor Cap prepared for installation

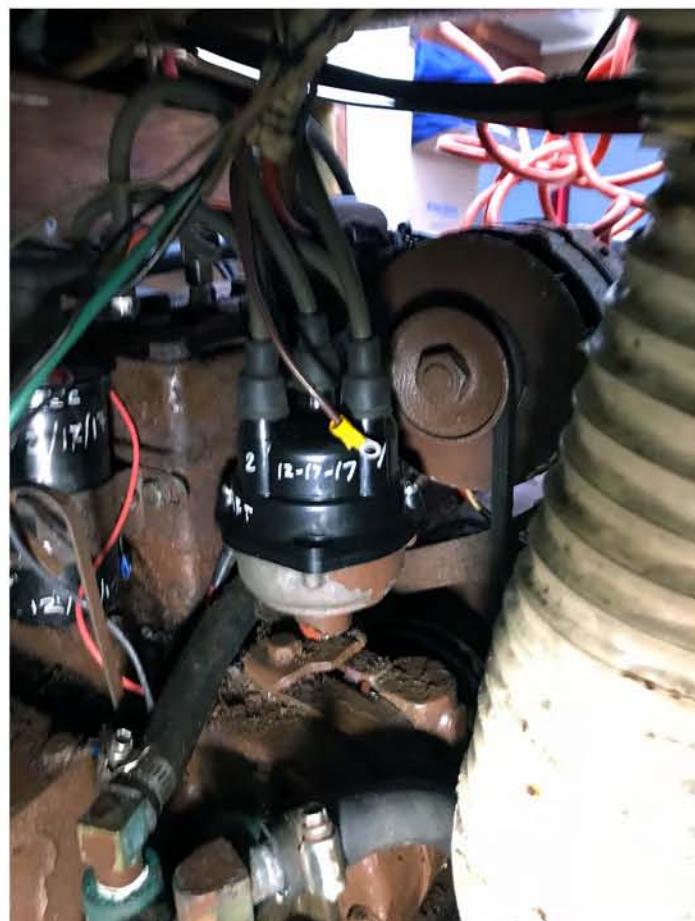
New Ignition Components Installed with dates and cylinder numbers inscribed
