Major Maintenance and Repair Action

Hull 269 – Jade

Maintenance or Repair Action: **Replace Marine Toilet Overboard Valve** Number: **001**

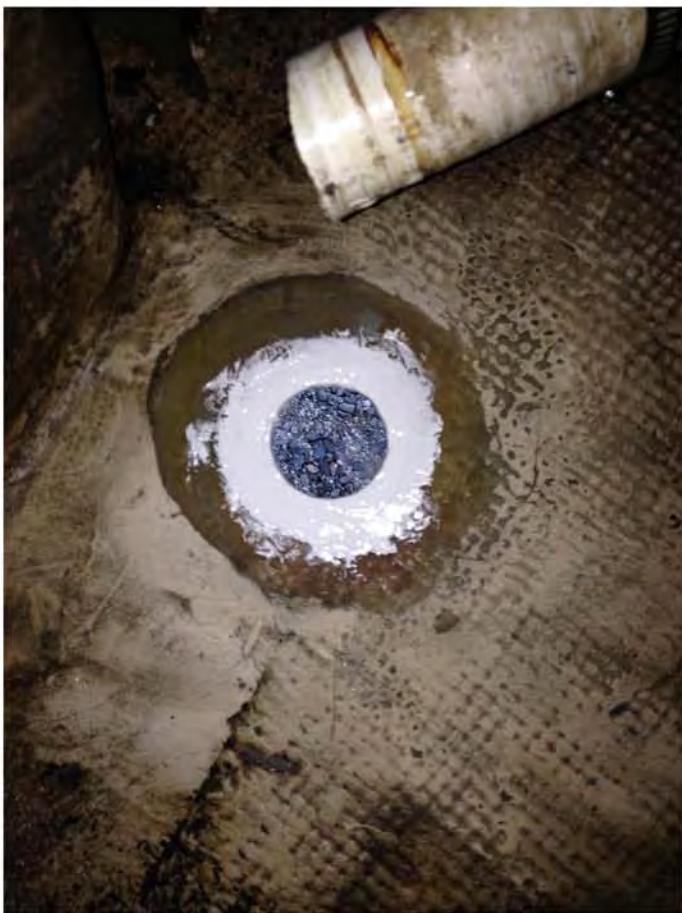
Hull from inside after removal
of old valve/through-hull assembly

The Perko fittings found during research were very expensive. Therefore, bronze and brass fittings listed below were found to be adequate replacements according to West Marine representative. However, the old fitting had to be cut out using a “saws-all” (reciprocating saw) – again, the West Marine representative was helpful in relaying the concept. The fitting was cut almost flush to the bilge. Then five radial cuts from the center outwards were made, allowing a chisel to be used to knock out the wedge shaped pieces remaining. The radial cuts had to be filled in with Marine-Tex Epoxy and sanded smooth.

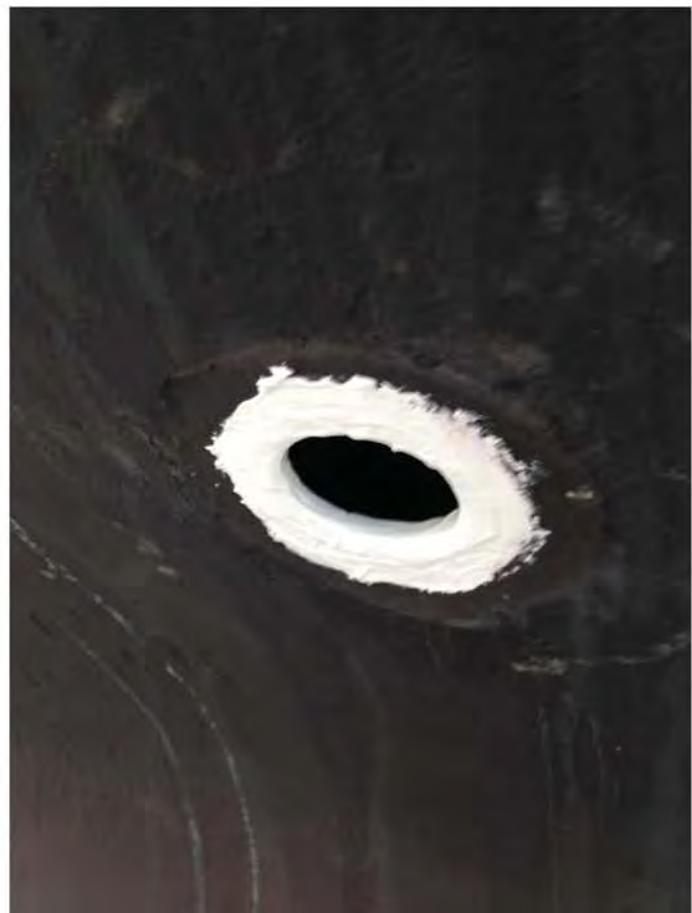
Hull from outside after removal
of old valve/through-hull assembly

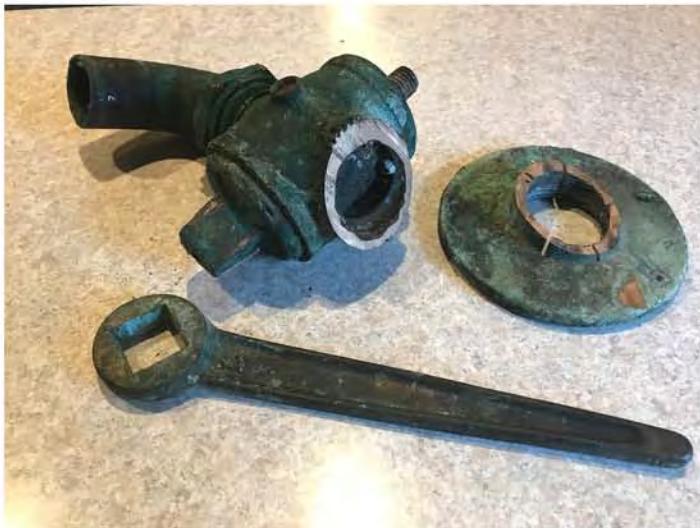
| Reason for Action | Old or original bronze valve stuck in the closed position and could not be turned using penetrating oil and pipe wrenches | System | Marine Toilet |

Old Perko valve and through-hull assembly. Note the radial cuts on the through-hull flange to facilitate the removal of the old threaded collar (not pictured). Old valve was frozen stuck in the closed position. Grounding wire (green - see left picture) was attached to the flange with a brass screw. A brass lug was connected and attached with a stainless steel hose clamp to the new valve (not pictured).

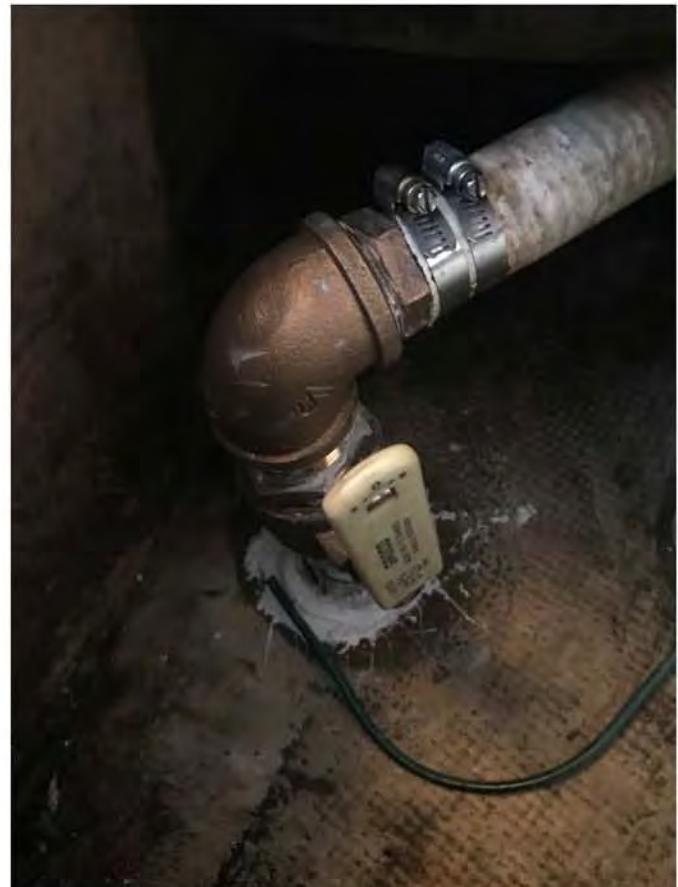
Final through-hull and valve hardware installed to original flexible hose from marine toilet system

A new bronze through-hull valve was installed and sealed on both sides with 3M 5200 Fast Cure Marine Sealant, as recommended from the West Marine representative. Finally, a 90 degree brass elbow, nipple, valve with grease fitting, and 2" NPT pipe to hose barb fitting was installed to connect to the original flexible hose with two existing stainless steel hose clamps. All joints were coated with “pipe dope” (pipe thread sealant) vice Teflon tape. Two copper electrical grounding connectors were clamped onto the through-hull fitting and connected to the adjacent 1-½" water supply valve as per the original configuration. The valve was lubricated with marine grade (STP) grease via the zerk fitting.

After launch on May 10, 2018, no leaks were detected from the valve or through-hull fitting. No diagrams of the toilet system exist. It was discovered later that Sanitary Systems were aftermarket options for Pearson Yachts.
